Assessment of Paint Layers Quality

1. Field investigations on a railway bridge

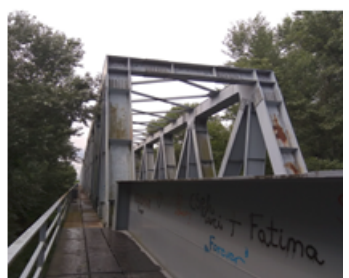
Fig. 4. The merger of the Eastern sector (repainted in 2013) and the central section (the original paint in 1986)

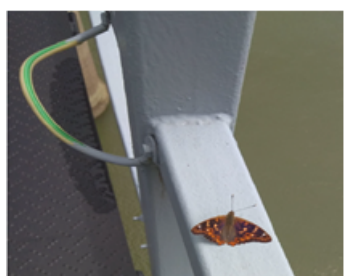
The electrical continuity (electrical safety) between the metal elements of the investigated bridge is adequately ensured (fig. 5). The bridge is located in a protected area Natura 2000 with a special biodiversity (flora and fauna)

Fig. 5. Ensuring electrical continuity between the metallic elements of the bridge

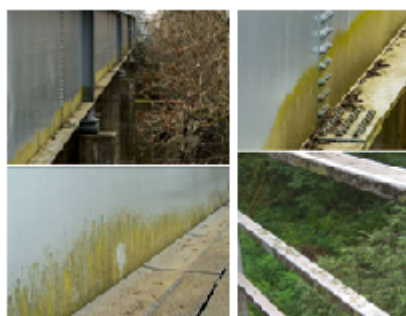
- on the West section, (lattice-girder structures), repainted in 2014, the paint layers are continuous, do not show exfoliations and / or bio fouling traces;
- on the central section (lattice-girder structures) the paint layers applied in 1986 show rust traces (5-10 % of the surface) and exfoliation between the paint layers (10-20 % of the surface);
- on the Eastern section, (slab bridge structures), repainted in 2013, does not show exfoliation between layers but has relatively large areas (5-10 % of the surface) covered with bio fouling (fig. 6, fig. 7 and fig. 8).

Fig. 6. Extensive areas of bio fouling on slab structures and on handrail

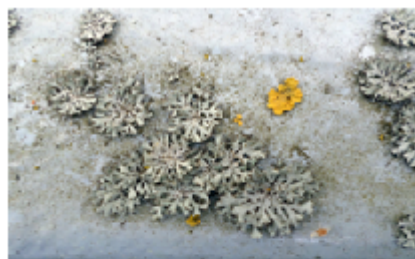
Fig. 7. Detail - area mainly covered by ferns (gray - *Hypogymnia physodes* and yellow - *Xanthoria parietina*) and molds

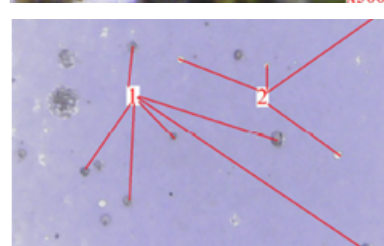
Fig. 12. X500 image captured with USB microscope on cleaned and washed paint - surface with orange peel depressions (white - traces of *Aspergillus fumigatus*, black - traces of *Aspergillus Niger* and green - traces of algae / moss)

By analyzing figure 11 and figure 12 it is observed that due to the action of microorganisms, especially of filamentous molds, the paint layer surface became as orange peel and in recesses are fixed both filamentous fungi and micro-plants capable of photosynthesis (alge and moss).

This observation suggests that the dyeing material was inhomogenetically metabolized by filamentous fungi and that in the recesses formed conditions for the growth of algae and moss.
