# Failure Analysis of Retrieved Polyethylene Insert in Total Knee Replacement

*The paper presents the study on the retrieved polyethylene components from total knee prosthesis. For the longevity of total knee arthroplasty it is very important to predict the polyethylene wear and optimize the prosthetic design. The functionality of the total knee prosthesis is affected by contact stress, sliding motion and kinematics of the prosthesis components. The most important factors which cause long-term failure of a prosthetic joint are: macroscopic fracture of the metallic components, polyethylene component wear, corrosion process, and osteolysis. Even the prosthesis development over the past decade has included improvements in implant designs and use of advanced biomaterials, is still difficult to replace some classic biomaterials. Ultra-high molecular-weight polyethylene (UHMWPE) has been the primary material for the articulating surface in prostheses for nearly 40 years. Even now there are a number of problems with the UHMWPE, which cause troubles for the patients. On retrieved polyethylene components, 7 different defects were observed (burnishing, scratching, pitting, surface deformati

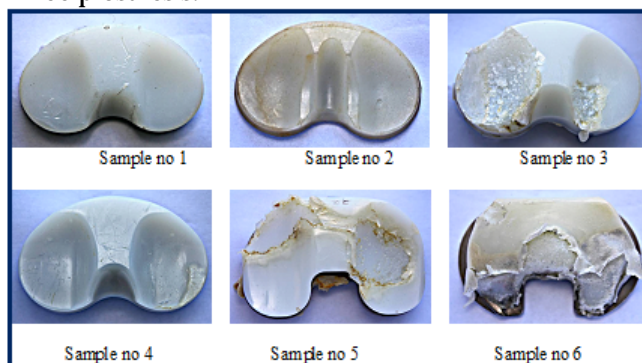
We examined 36 tibial components of knee prosthesis retrieved at revision between 3 and 5 years after implantation. After a carefully analysis of the clinical data, we select six representatives explants from all this series of polyethylene components because the main objective of our study was to identify and analyze the types of wear defects and also the areas where the wear defects appears on the polyethylene component. The macroscopic view of the selected polyethylene components from the failed total knee prosthesis that will be investigated are shown in figure 1.

Fig. 1. Macroscopic images of the failed polyethylene components from total knee prosthesis selected for the study

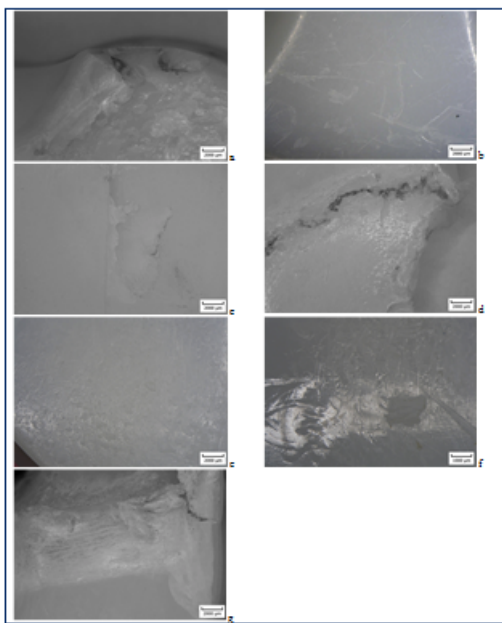
All of these modes were observed on our experimental retrieved samples, using stereomicroscopy analysis. The results are presented in figure 2.

In the authors experimental retrieved specimens, both longitudinal and transverse wear patterns *ripples* were observed consistent with the *natural* sliding and rolling movement of the knee.

Fig. 2. Stereomicroscopy images made on experimental samples highlighting the types of defects (a-surface deformation, b-scratches, c-debris, d-abrasion marks, e- pitting, f- burnishing, g- exfoliating)

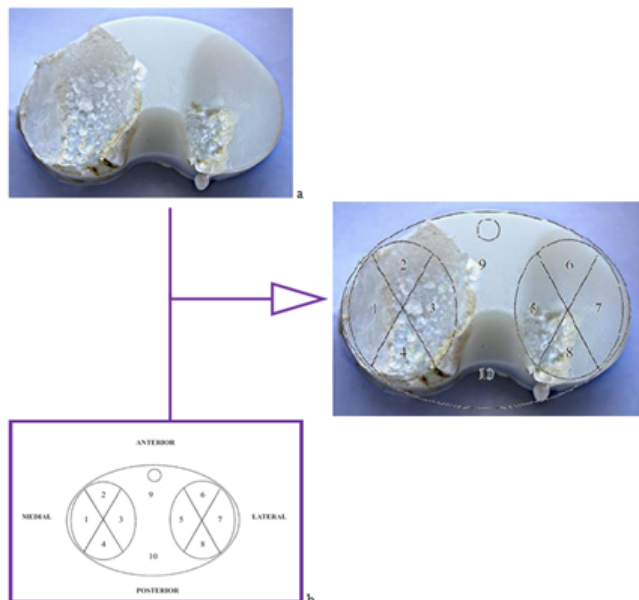
In order to define the location of wear on the retrieved polyethylene components where the damage occurred and make a quantitative analysis of the severity of wear, we use the scoring system described by Hood [6]. According this, each retrieved polyethylene component will be divided into 10 different sections (fig. 3). We calculated the surface defects score as follows: for each type of wear we give between 0 points (to wear 0%) and 3 (to wear over 50%) for each zone. For only one area the maximum

Fig. 3. Practical example of using Hood protocol in order to define the location of wear on the retrieved polyethylene components where the damage occurred (a-the explanted polyethylene sample, b-the grid model to locate the severity of damage on the polyethylene insert/Hood Model, c- the polyethylene and the grid model overlaid)

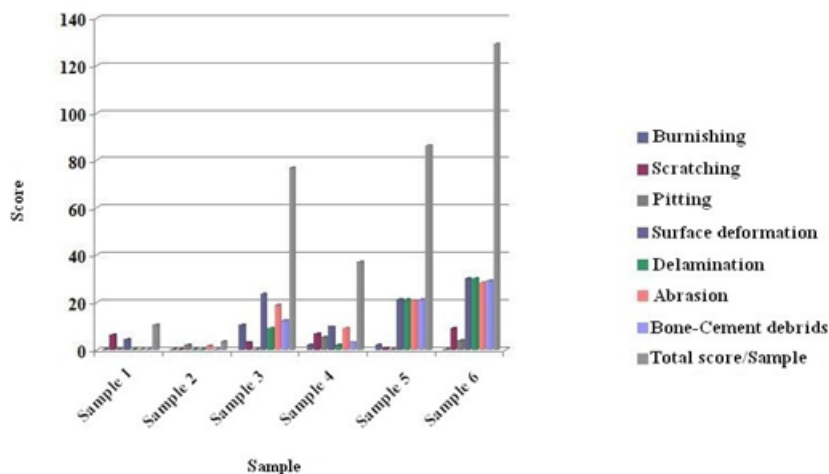
(a) Histogram score defect/sample

Two graphical representation were realized regarding the repartition of defects per each sample and about the repartition of defects per each area (fig. 4). We could mention that the most damaged area was seen on the medial and inside of the lateral sides in sections 1, 5 and 8, and the lowest amount of damage was see on the posterior zone on section 10. According the analysis of defects per each samples, we could conclude that the results are in concordance with the clinical data related to the period in use. One exception was observed, in the case of sample number 3. The authors considered that this component

Fig. 4. Graphical representation of the distribution of defects according Hood model: (a) distribution of defects per each sample and (b) the distribution of defects per each area.

show an accentuated rate of damage and failed much faster because the degradation was emphasized by the presence of bone cements particle on the polyethylene component surface.

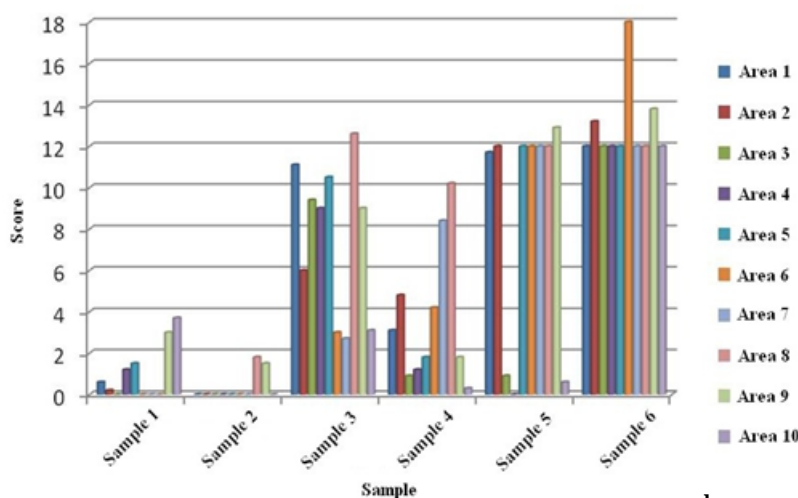
(b) histogram score defects/area

-Burnishing: Appears in the medial (1,3) and lateral (5,7) areas and less in the posterior zone and affects only a few samples.

-Scratching: Scratching was seen in all sections, most on the medial(1,4), anterior (9)and posterior (10) zones and less in the lateral zone.

-Pitting: Pitting was seen the most in medial(1,4) and anterior(9) zones and less pronounced in the other zones. Pitting affects only a few samples.

-Surface deformation: Surface deformation was seen in medial, lateral and anterior zones and it's quite pronounced in (1,2,4-9) sections.

-Delamination: Delamination was seen the most on the medial, anterior and posterior sides in sections (1, 4) and on the lateral side in sections (7,8).

-Abrasion: Abrasion was seen the most on the lateral side in sections (7,8).

-Bone-cement debris: Bone and cement debris was seen the most on the medial and lateral sides in sections (1, 4) and least at the posterior side in section (10).
