Failure Cause Analysis of a 5 KW Wind Turbine Blade in Extreme Wind Conditions

TEODOR MILOS¹, ILARE BORDEASU^{1*}, RODICA BADARAU¹, ADRIAN BEJ¹, DORIN BORDEASU²

¹Politehnica University of Timisoara, 2 Piata Victoriei, 300006 Timisoara, Romania

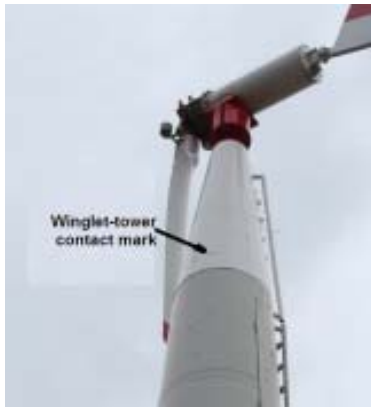
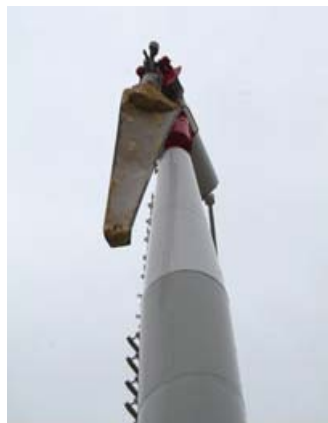
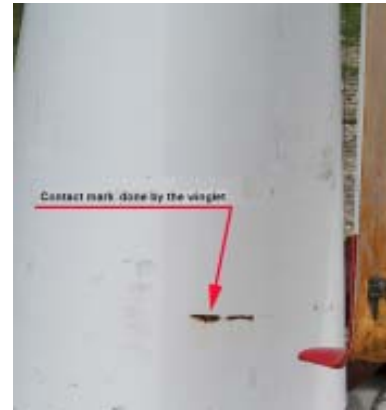
Winglet-tower
contact mark

Contact mark done by the winglet

Fig. 2. Pictures of wind turbine after the incident a) lateral view; b) front view ; c) zoom on the impact zone

Images captured on the site (fig. 2) reveal visible bold marks done through impact over the tower's conical section by the blade winglet which caused the rotor damage. At the same level there are paint scratches caused by the tangential touching after the blade broke off.

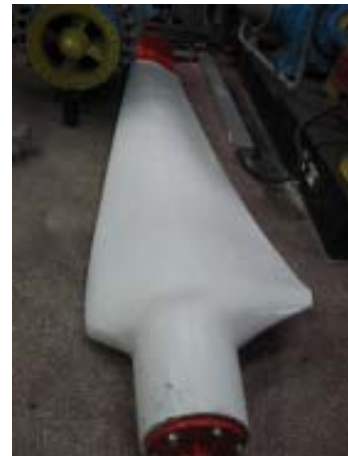
By analyzing all the three blades it was found that the last blade was affected by the breaking shock only in the tip area, due to the impact with the blade already broken in the first phase of the incident (fig. 3). Although it did not show substantial damages, the shaft flange of 50 mm thick, shown in figure 3, was broken off showing the magnitude of the shock.

Fig. 3 The least damaged blade on the shell, but having the shaft broken

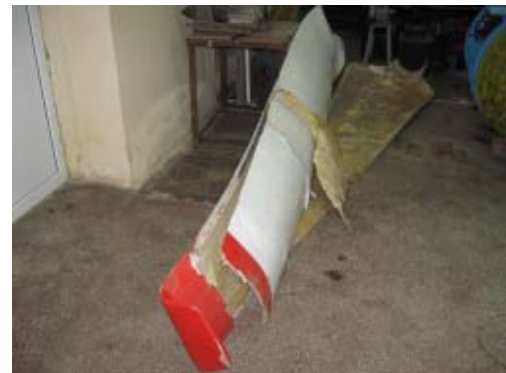
Figure 4 shows the damages of the first broken blade, which were increased when hitting the ground

The study of the damaged blades shows that the FGRP shell in the metallic reinforcing insertion area, withstood without any cracking or breaking. However, according to our design marks and by analyzing the recorded video, the first blade detached from the rotor and torn off in two (i.e. inner and outer part) due to the binding failure (fig. 4). In this figure it can be seen that the polyurethane foam did not had uniform adhesion all over the surface of each of the two shells. We consider that the damage of the FGRP structure of the blade that touched the tower was caused by elastic deformations with large blade deflections,

Fig. 4. Broken blade

breaking of the two flanges of the blade shafts was caused through the impact with the tower, which generated unexpected loads not considered in the turbine design stage, and consequently overloaded the shaft. The reason for this is that after the first failure the unbalanced rotor masses developed additional loads, including vibrations over the emergency braking threshold.

Based on the analysis performed on the broken blade of a 5 kW wind turbine and looking further for correcting and improving the blade reliability involving design, mechanical strength and manufacturing technology, the following improving solutions are proposed:

- depending on the specific thickness prescribed for the FGRP material, the maximum number of layers (3) of fiberglass embedded in resin matrix will be used, and consequently the shell thickness of FGRP in the leading edge will be increased from 5 mm (current situation) to 15 mm;

- before gluing the two shell halves it will be strictly verified if there is a direct contact along whole gluing outline between the surfaces which have to be glued, and after gluing the two parts the blade shell will be kept in a pressing device in order to facilitate the glue to penetrate into the microstructure of the resin and particularly to bind to the fiberglass mat;

- prior to injecting the polyurethane foam, the blades have to be restrained rigidly in a device that does not allow any deformation of the FGRP shell after the foam was injected. During the curing stage the foam expands creating pressure inside the shell;

- the injection of the polyurethane foam will be performed slowly, with the blades kept in vertical position, to facilitate as much as possible a total elimination of the indoor air from the inside of the shell;

- the metal insertion must to be well glued on the two FGRP shells of the blade ensuring an effective sealing and so avoiding the moist air to penetrate inside the blade shell.

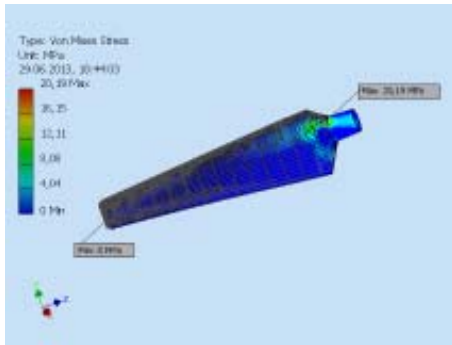
Fig. 6. Von Mises Stress distribution

• Figure 6 gives the variation of Von Mises Stress - which represents the summation of the longitudinal and tangential stresses based on Von Mises Stress Method. The maximum values are located in the transitional area from the circular section to the airfoil shaped section. The presence of the reinforcing metal insertion in this area greatly reduces the loads in the GFRP structure. The maximum stress values does not exceed the allowable yield strength of 49.6 MP associated with the assumed blade GFRP material;

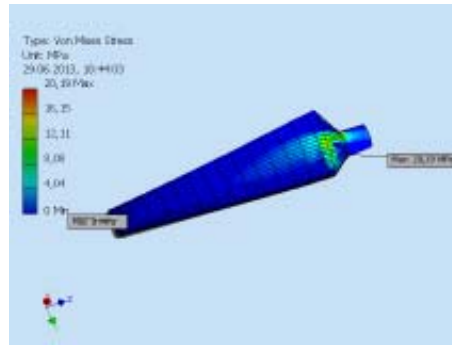
Fig. 7. 1st Principal Stress distribution

• Figure 7 shows the variation of tensile (compression) stress. The maximum values occur approximately in the same area as Von Mises Stress does. Here it can be also noted that the stress values do not exceed the allowable yield strength of 49.6 MPa;

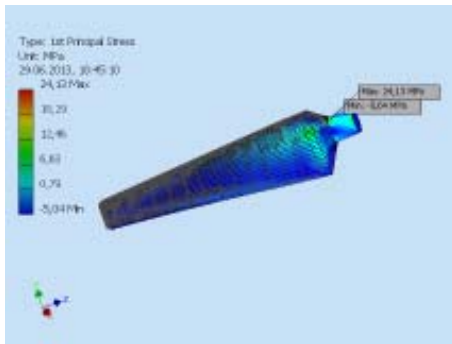
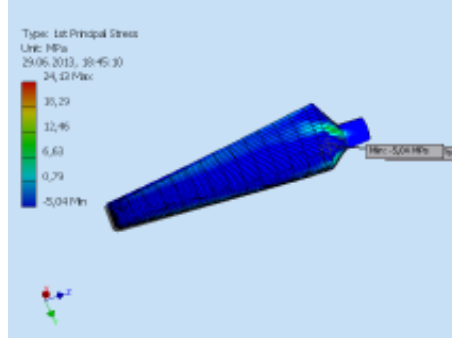
Fig. 8. 3rd Principal Stress distribution

• Figure 8 shows the variation of the shear stress. Maximum values appear in the blade root sections, on the leading edge. It is also notable that the allowable yield strength of the GFRP material of 49.6 MPa is not exceeded;

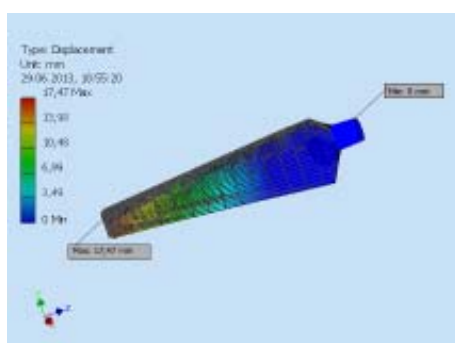
• Figure 9 shows that the maximum displacement of 17.47 mm produced at the tip of the blade, opposite to the root section, has acceptable values placed into the range of those specified within the blade technical design;

Fig. 9. Displacement distribution

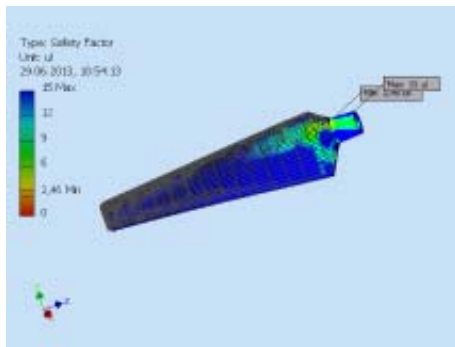
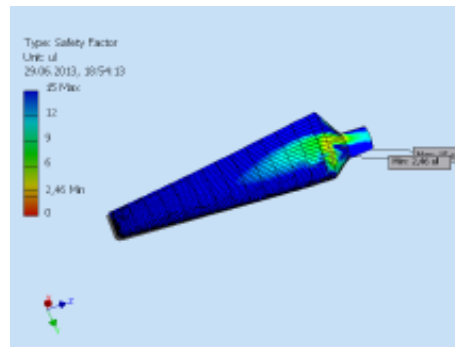
• Figure 10 provides data referring the safety factor values, ranging between 2.46 and 15 regarding the yield strength limit. It can be noted that the minimum value is associated to the same area where the Von Mises Stress gives the maximum value, and revealing consequently the connection between these two parameters. Also, the minimum value shows that the most stressed section requires to be reinforced;

Fig. 10. Safety Factor distribution

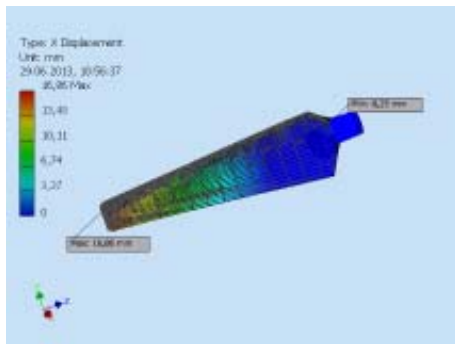
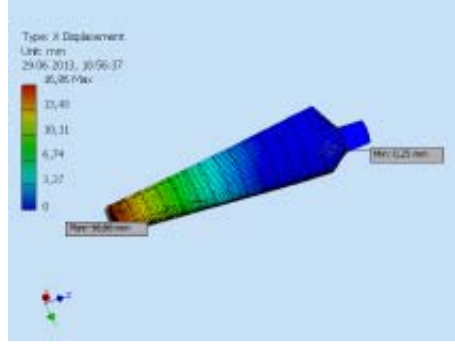
• Figure 11 shows that the maximum displacement are on X axis direction, the direction from which the wind blows and acts normal on the blade surface, causing the elastic deformation, which caused the impact between the winglet and the tower.

Fig. 11. X Displacement distribution

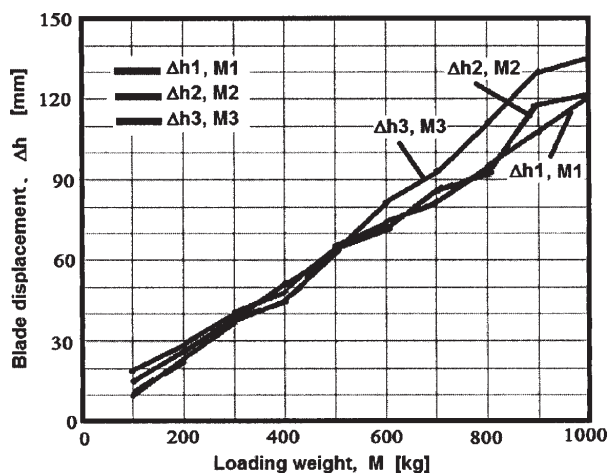
Fig. 13. The variation of blade displacement under the sandbag loading

The testing results, showing the variation of the blade tip displacement under the applied load, are given graphically in figure 13. The graphic reveals a similar elastic behaviour of all three blades.

The comparison between the displacement on X axis resulted through numerical simulation of 16.86 mm with the average value obtained by the static test of about 28mm reveals a significant difference. The reason for this difference can be explained by the weight distribution of the sandbags which is not quite similar with the force given by the pressure load on the blade inner part, where the chord of the airfoil (i.e. the width of the blade) from the root and tip is very different (350 mm at the tip and 800 mm at the root). However, during the static test the blades have not been plastically deformed under load conditions which generally do not exceed the loadings generated by air flow dynamic pressure in extreme weather conditions (wind speed up to 30 m/s).
