# Comparison of Classic and Metal Reinforced Maxillary Acrylic Complete Dentures Fracture Resistance

*The aim of our study was to evaluate fracture resistance of the PMMA complete dentures and to make a comparison between the classic acrylic maxillary complete dentures and the metal-reinforced ones, in terms of fracture resistance during function and to compare the fracture pattern of the two groups of complete dentures. We used maxillary complete dentures made of heat-processed acrylate, 5 exclusively and 5 in which a metal-cast net in the form of a mesh was inserted after being casted, worn by patients for a period of 5 years. A bilateral progressive force was applied to the PM2-M1 area until the samples failed, recording the force value at which the first change occurred. A Universal Loading Machine was used. The results were analyzed using the ANOVA method. For the classic acrylic complete dentures group, the minimum fracture force value was 1060 N, the maximum fracture force value being 2443 N. For the reinforced complete dentures group, the minimum fracture force value was 3320 N, the maximum value being 3760 N. Statistical analysis of data using the ANOVA shows that the res

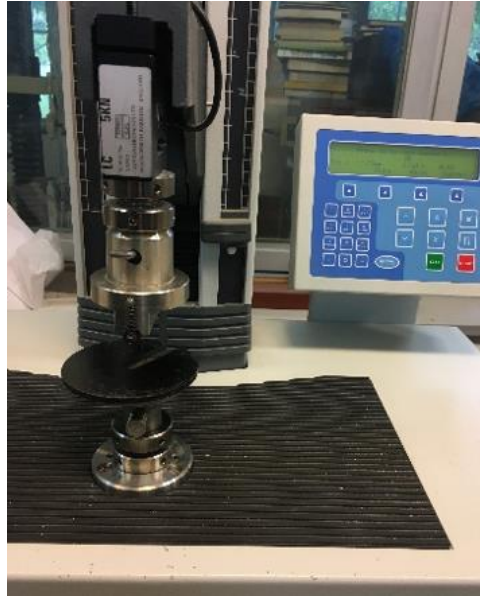
Fig. 1. The universal Loading Machine (Lloyd Instruments)

The study was carried out on a number of 10 upper complete acrylic dentures, with bases and artificial teeth made of thermoplastic PMMA, of which 5 had bases made exclusively of heat-processed acrylate and 5 were made of heat-processed acrylate in which a metal-cast net in the form of a mesh was inserted after being casted; all the artificial teeth used were acrylic prefabricated units. To ensure similarity to oral conditions, we used two methods; first, simulating mucosal resilience with a putty condensation silicone that exhibits elasticity after setting, and using complete dentures worn by patients for a period of 5 years. Samples were subjected to a bilateral progressive force applied to the PM2-M1 area. The flexural load was applied until the samples failed, recording the force value at which the first change occurred. A Universal Loading Machine (Lloyd Instruments) was used, with a maximum force of 5kN and a crosshead speed of 1.0 mm/min (Figure 1). NEXYGEN Data Analysis Software was used to record the results. A representative fractured specimen is shown in Figure 2. The graphics show the dependency between load and extension for each sample, recording the force value at which the fracture occurred. At the same time, the area of minimal denture resistance was highlighted for each sample. The results were statistically analyzed using the ANOVA method.

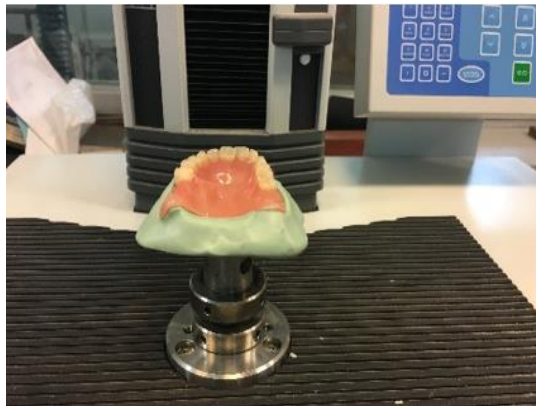
Fig. 2. Fractured specimen from the classical acrylic complete dentures group

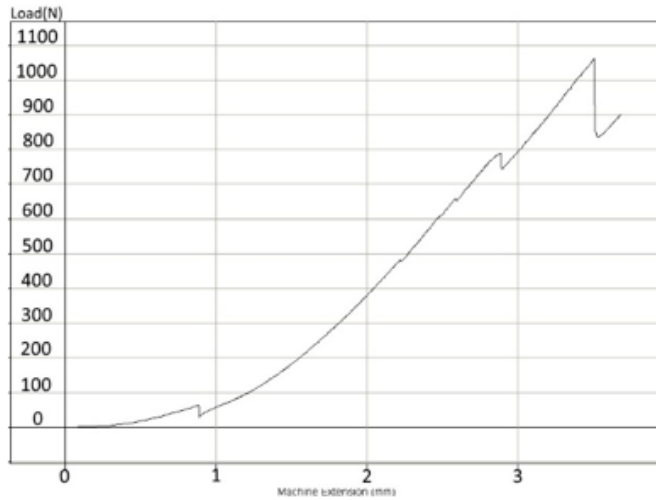
Fig. 3. The minimum fracture force value for the classic acrylic complete dentures group

For the classic acrylic complete dentures group, the minimum fracture force value was 1060 N, the maximum fracture force value being 2443 N, with an average of 1722.4 N plus/minus 572,98 N (the standard deviation). Fracture force values for the classic complete dentures is shown in Table 1. The graph with the minimum fracture force values is shown in Figure 3 and the maximum in Figure 4.

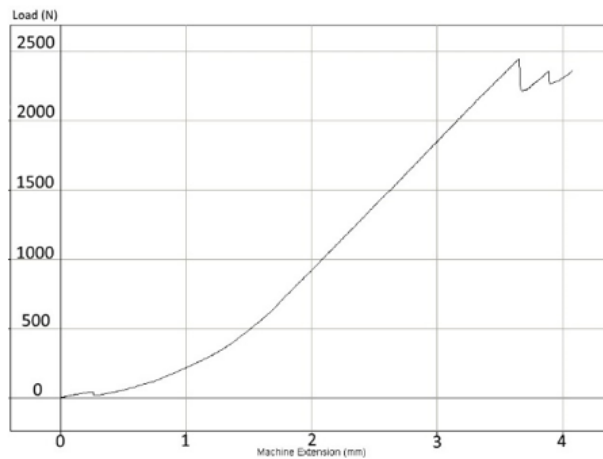
Fig. 4. The maximum fracture force value for the classic acrylic complete dentures group

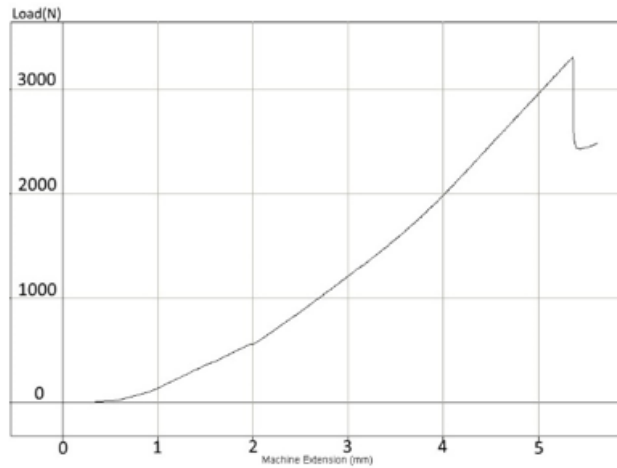
Fig. 5. The minimum fracture force value for the reinforced complete dentures group

For the reinforced complete dentures group, the minimum fracture force value was 3320 N, the maximum value being 3760 N, with an average of 3559 N plus/minus 188,49 N (the standard deviation). Fracture force values for the reinforced complete dentures are shown in Table 2. The graph with the minimum fracture force value is shown in Figure 5 and the maximum in Figure 6.

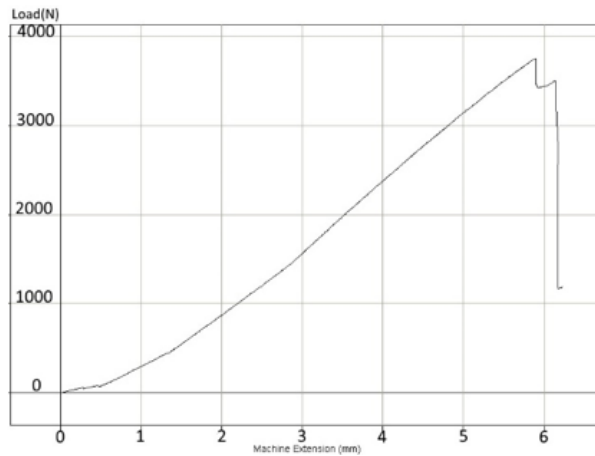
Fig. 6. The maximum fracture force value for the reinforced complete dentures group

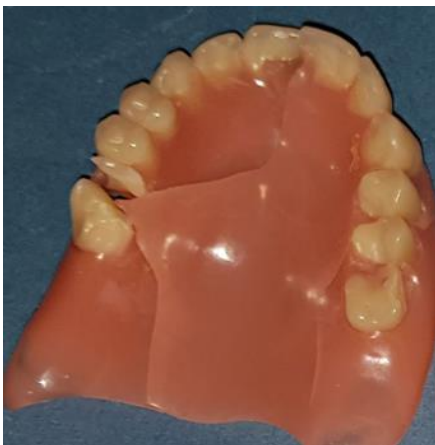
Fig. 7. Classic acrylic maxillary denture fractured into multiple pieces

The dentures from the classic maxillary complete dentures group proved to be more susceptible to fracturing into multiple pieces, involving both the base and the acrylic teeth in most cases, as shown in Figure 7 and Table 5, while those pertaining to the reinforced maxillary complete dentures group were more resistant to fractures, as shown in Figure 8 and Table 6.

All the dentures from the classic acrylic complete dentures group fractured along two or more fracture lines, most of them involving also fractures on the acrylic teeth and breaking into multiple pieces, while all the dentures from the reinforced complete dentures group fractured on one or two fracture lines, most of them without detachable fragments and involving also fractures on the acrylic teeth. For both groups, at least one fracture line was paramedian.

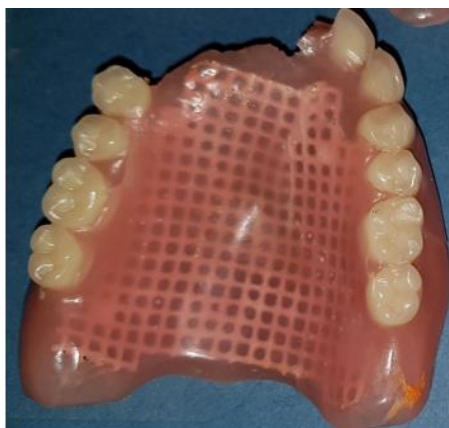
Fig. 8. Metal reinforced acrylic maxillary denture fractured mostly peripheral, outside the metal mesh zone
