Failure Cause Analysis of a 5 KW Wind Turbine Blade in Extreme Wind Conditions

TEODOR MILOS¹, ILARE BORDEASU^{1*}, RODICA BADARAU¹, ADRIAN BEJ¹, DORIN BORDEASU²

¹Politehnica University of Timisoara, 2 Piata Victoriei, 300006 Timisoara, Romania

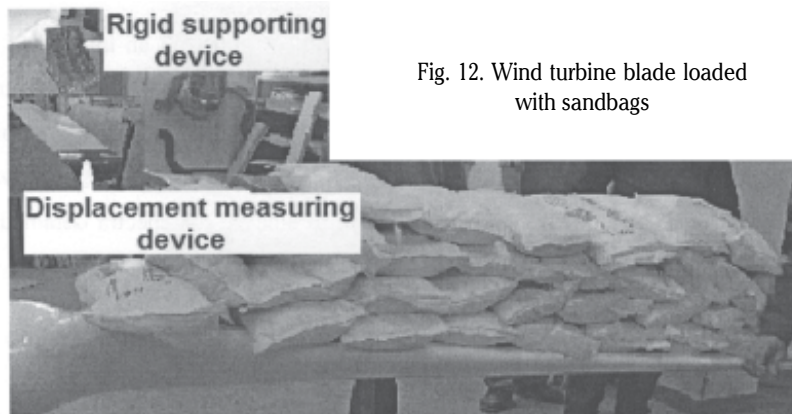
Fig. 12. Wind turbine blade loaded with sandbags

Prior to being mounted on the rotor the three blades were statically tested by distributed loading with sandbags, each one having 25 kg. For this purpose each blade was fixed in horizontal position on a rigid supporting device, (fig. 12). In order to reduce the risk of on-site blade failure, as well as, to avoid any fracture during testing (nondestructive conditions) the maximum load was
