Change in the Depth of Scratch on the Polyethylene Gas Pipe after Squeezing with the Squeeze - off Tool

This research studies the influence of scratches on the polyethylene gas pipes after squeezing with the squeeze-off tool in order to stop gas flow due to an intervention of the gas pipeline. Problem occurs when there is a need to make a decision whether it is safe to squeeze the pipe with scratches. The goal of the research is to determine the change in the depth of scratches on the polyethylene gas pipe after squeezing with the squeeze-off tool. After the experimental research it was determined that there would be a change in the depth of scratch. The change of the depth of scratch positioned on the squeeze-off ear would be considerably bigger when compared to the depth change of a scratch positioned under the upper cylinder of the squeeze-off tool. Based on the resulting data, it is a recommendation of the author not to squeeze the pipe if it has scratches. If the squeezing if inevitable on the place where there is a scratch, the squeeze-off tool needs to be positioned under the upper cylinder of the squeeze-off tool.

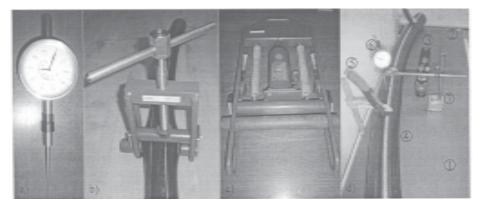
Fig. 3. Units for testing polyethylene gas pipes

The depths of scratches were measured on testing table shown in picture 3d. Pipe 4 was set on the table 1 and squeezed with clamp 5. Horizontality of the testing table was determined by setting screws and nuts 2, and was checked with water label 3. Comparator 6 is positioned by using stand 7.

Squeezing the pipes was done completely following the recommendations of Rule Book DVGW – GW 332 [3]. Squeeze-off tool of manufacturer "Georg Fischer", model S1 and model S2 was used. Model S1, figure 2b, is used for squeezing the pipes with outside diameter from DN20 to DN63 and SDR11, while model S2, figure 3c, was used to squeeze pipe with outside diameter from DN63 to DN160 and SDR 11 and SDR 17. Squeezing ratio SR is set on value 0.8 by using guard of the squeeze-off tool. After releasing the pipes, re-reounding clamps of the same manufacturer were used to bring back the circular section of the pipe for the pipes with outside diameter DN63, DN80 i DN110. Comparator of manufacturer KS was used, with resolution 0.01 mm and measuring range from 0 to 100 mm.

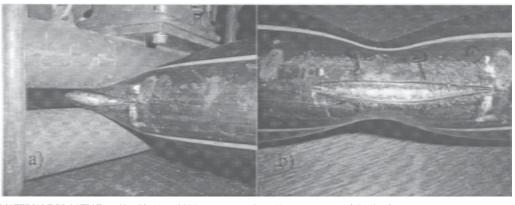
Fig. 4 Forming of a scotch at scratches on squeeze-off ears on pipes with outside diameter DN110

than the allowed border value recommended by the standard, but there is an initiating of a scotch, figure 4.

When a scratch is positioned at the squeeze-off ear of the pipe, the place where during the squeezing, strenching
